AGCO Application Crop Tour Field Report No. 1: Sprayer Cleanout and System Priming

With today's arsenal of weed-control products, equipment and practices that prevent contamination are crucial to avoiding herbicide damage.

September 29, 2020

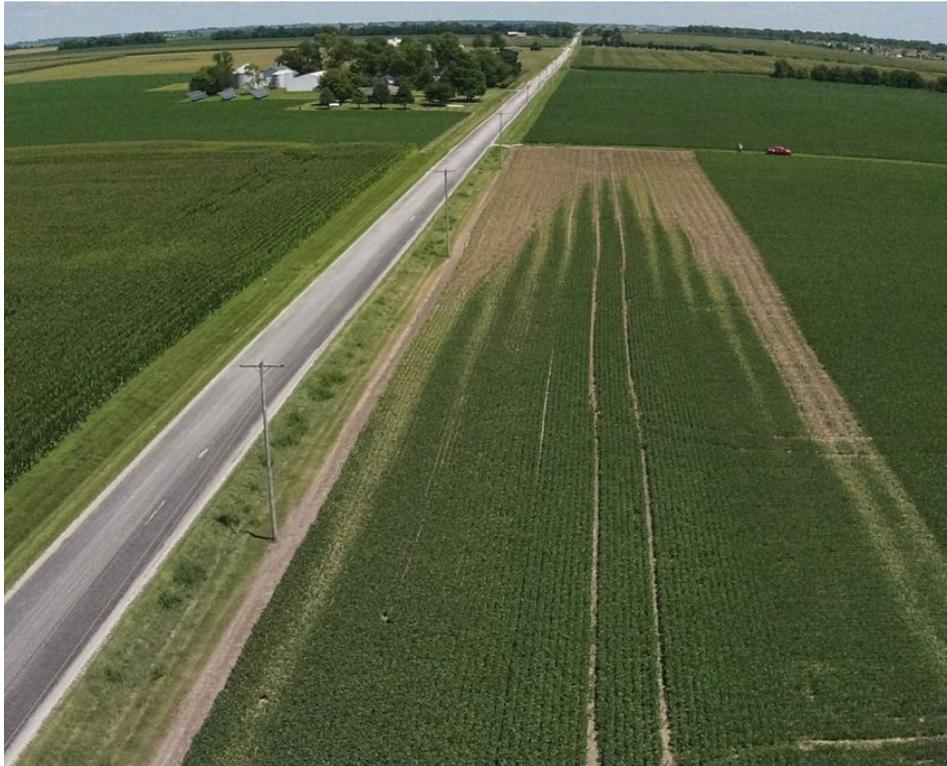
Improper sprayer cleanout can cause herbicide injury to a producer’s crop. Such damage can be identified by its recognizable V-shaped pattern, as seen here. As the first chemical is flushed from the sprayer, the new chemical enters the boom at the center and pushes the first chemical out of the boom from the center toward the tips. Sprayers equipped with self-priming, recirculating booms and product-recovery systems help to prevent this type of injury.

In this year’s Application Crop Tour plots, AGCO agronomists demonstrated how improper cleanout can damage crops. In Georgia, they contaminated sprayer booms with Valor® pre-emergent herbicide, then sprayed cotton plots. In Illinois, they contaminated the booms with Capreno® corn herbicide before spraying soybeans. In both cases, the crops showed herbicide injury.

“When the spray boom hasn’t been cleaned out properly, the new chemical enters the boom at the center and pushes the first chemical out of the boom from the center toward the tips, creating a recognizable V-shaped pattern of crop damage,” Lee says.
